OSWEGO RIVER BASIN
PUNCH BOWL DAM

SCHUYLER COUNTY, NEW YORK
INVENTORY NO. N.Y. 1343

PHASE I INSPECTION REPORT
NATIONAL DAM SAFETY PROGRAM
PUNCH BOWL DAM
N.Y. 1343
DEC I.D. NO. 60C-4405
OSWEGO RIVER BASIN
SCHUYLER COUNTY, NEW YORK

Date of Inspection: June 25, 1981 and July 15, 1981

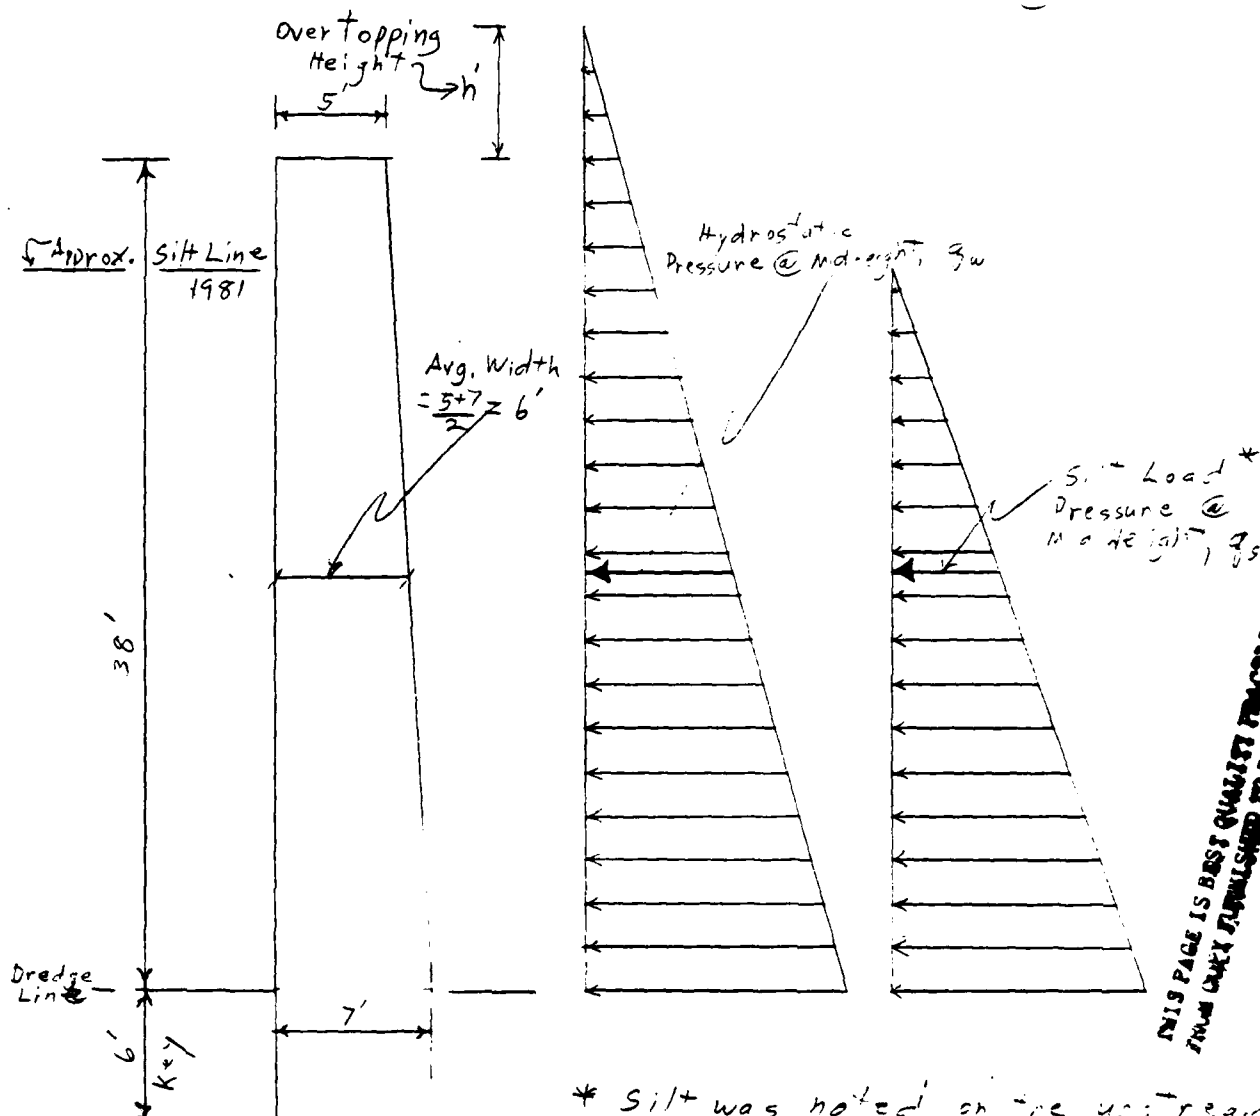
Typical Cross-Section of Dam & Loading

* Silt was noted on the upstream face of the dam approximately 5' or 6' below the crest. Assume that the silt is 5' below the dam crest, (Per Conversation with J.E. 7/28/81)
